DRAFT ENVIRONMENTAL IMPACT REPORT
APPENDICES

SUSCOL MOUNTAIN VINEYARDS

EROSION CONTROL PLAN
APPLICATION NO. P09-00176-ECPA

MARCH 2012

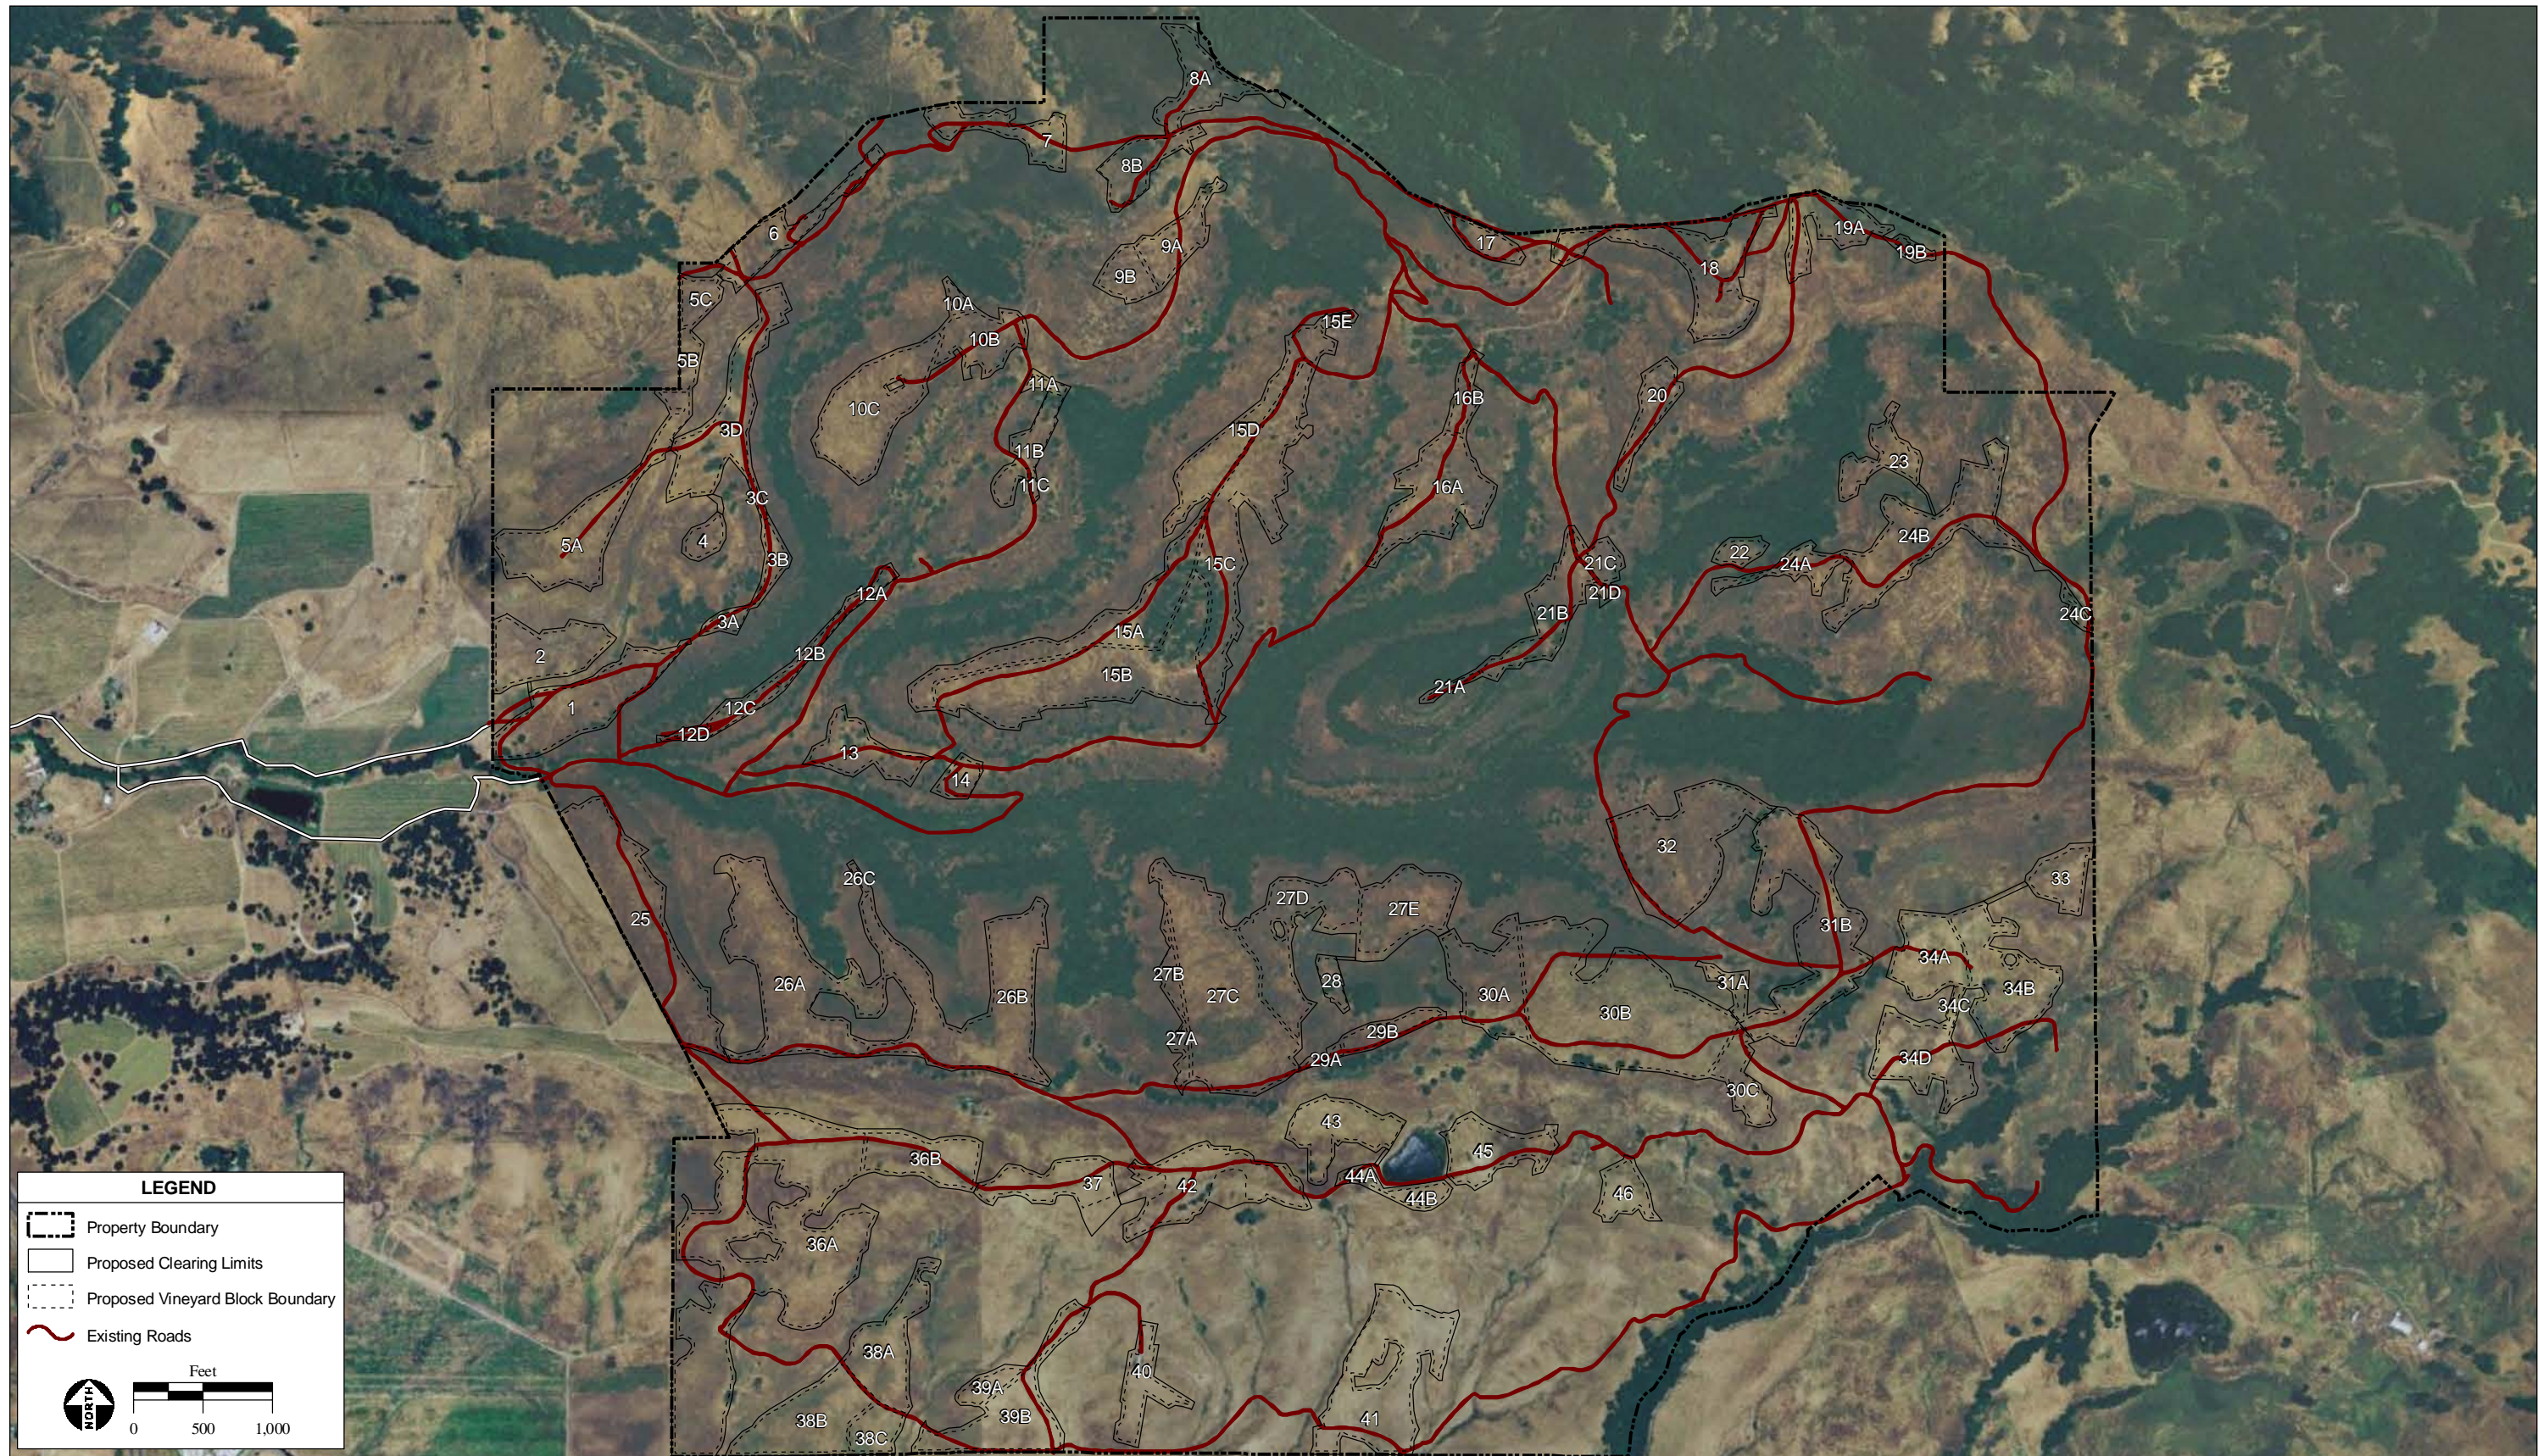
Figure 2-3
Aerial Photograph

SOURCE: LandVoyage Aerial Photograph, 6/15/2005; Napa County, 2008; AES 2009.

Figure 2-1 shows a regional location map of the area. **Figure 2-2** identifies the site and vicinity of Suscol Mountain Vineyards. An aerial photograph with Napa County parcels are shown in **Figure 2-3** and existing roads on the property are shown in **Figure 2-4**.

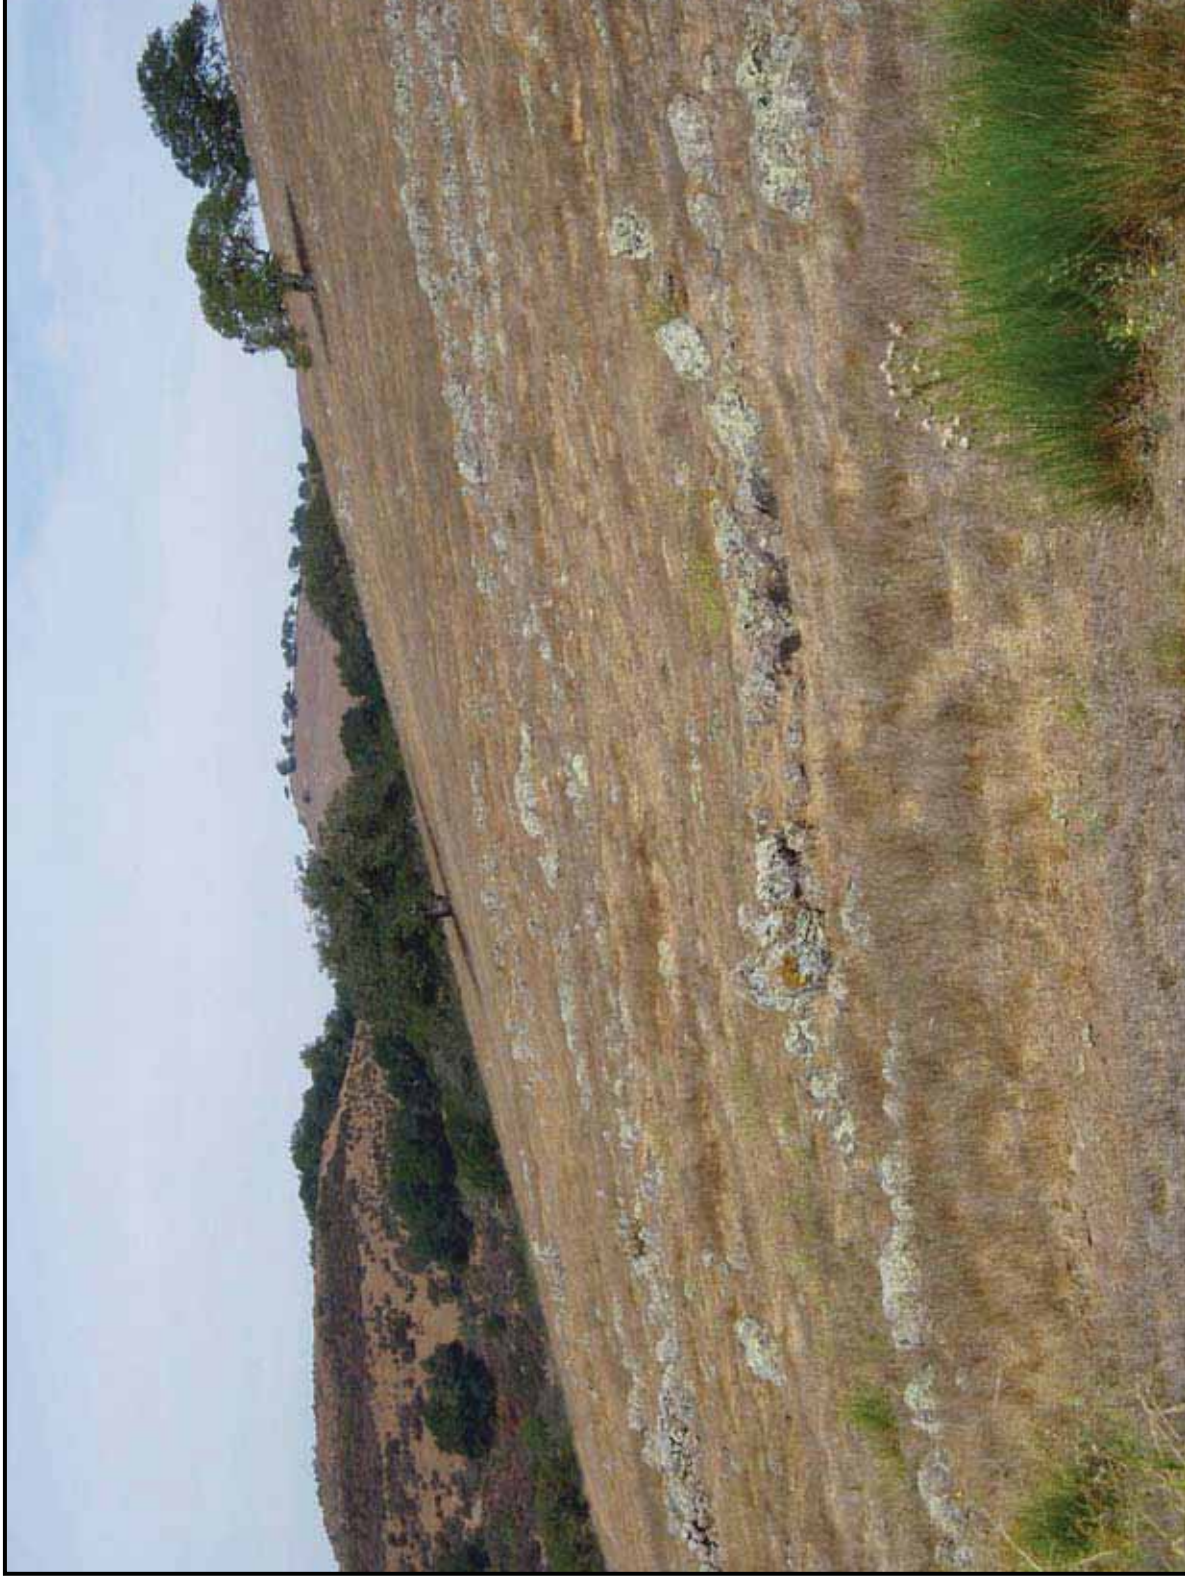
Figure 3. Photograph showing grazed conditions in the upper Suscol Creek watershed, Napa County, California. Image captured October 1, 2008 near spring 19. Note the large blocks of basalt present on the ground surface.

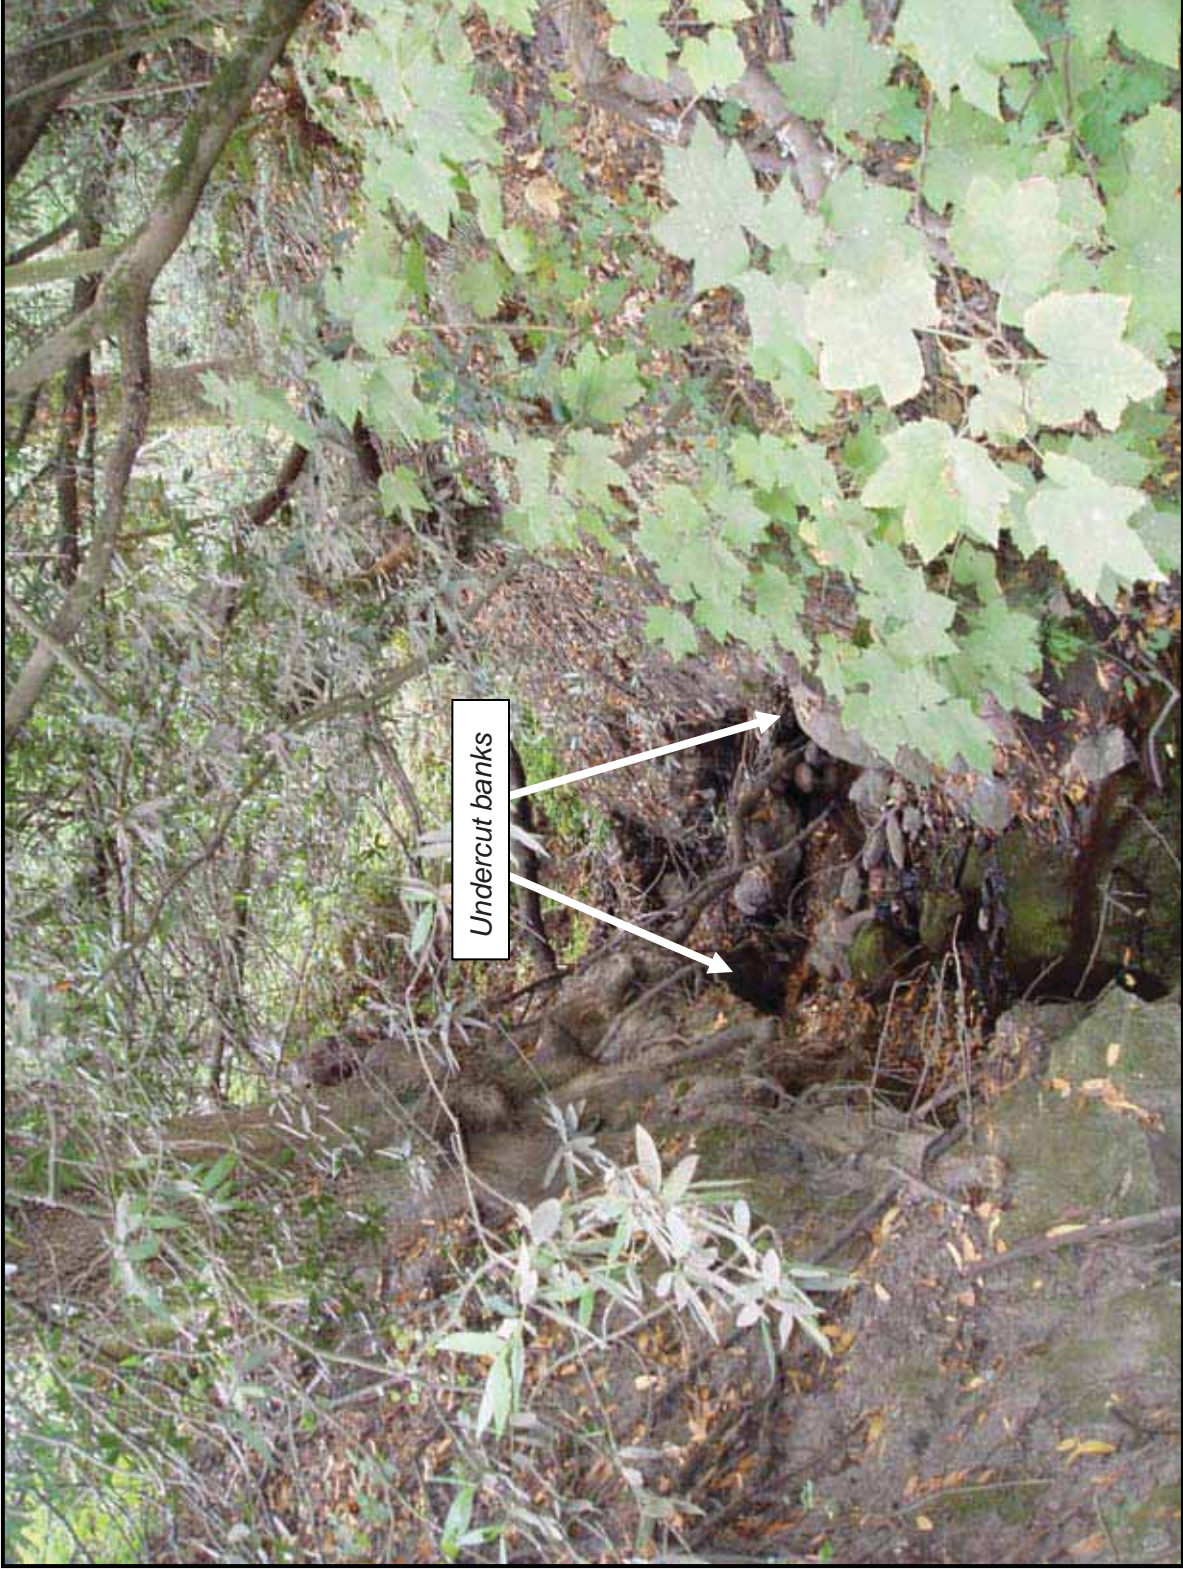
Figure 7. Localized incision and undercut banks on upper Suscol Creek, Suscol Mountain Ranch, Napa County, California. Photo captured October 1, 2008, approximately 1.7 miles upstream of the project property line. Photo taken looking upstream.

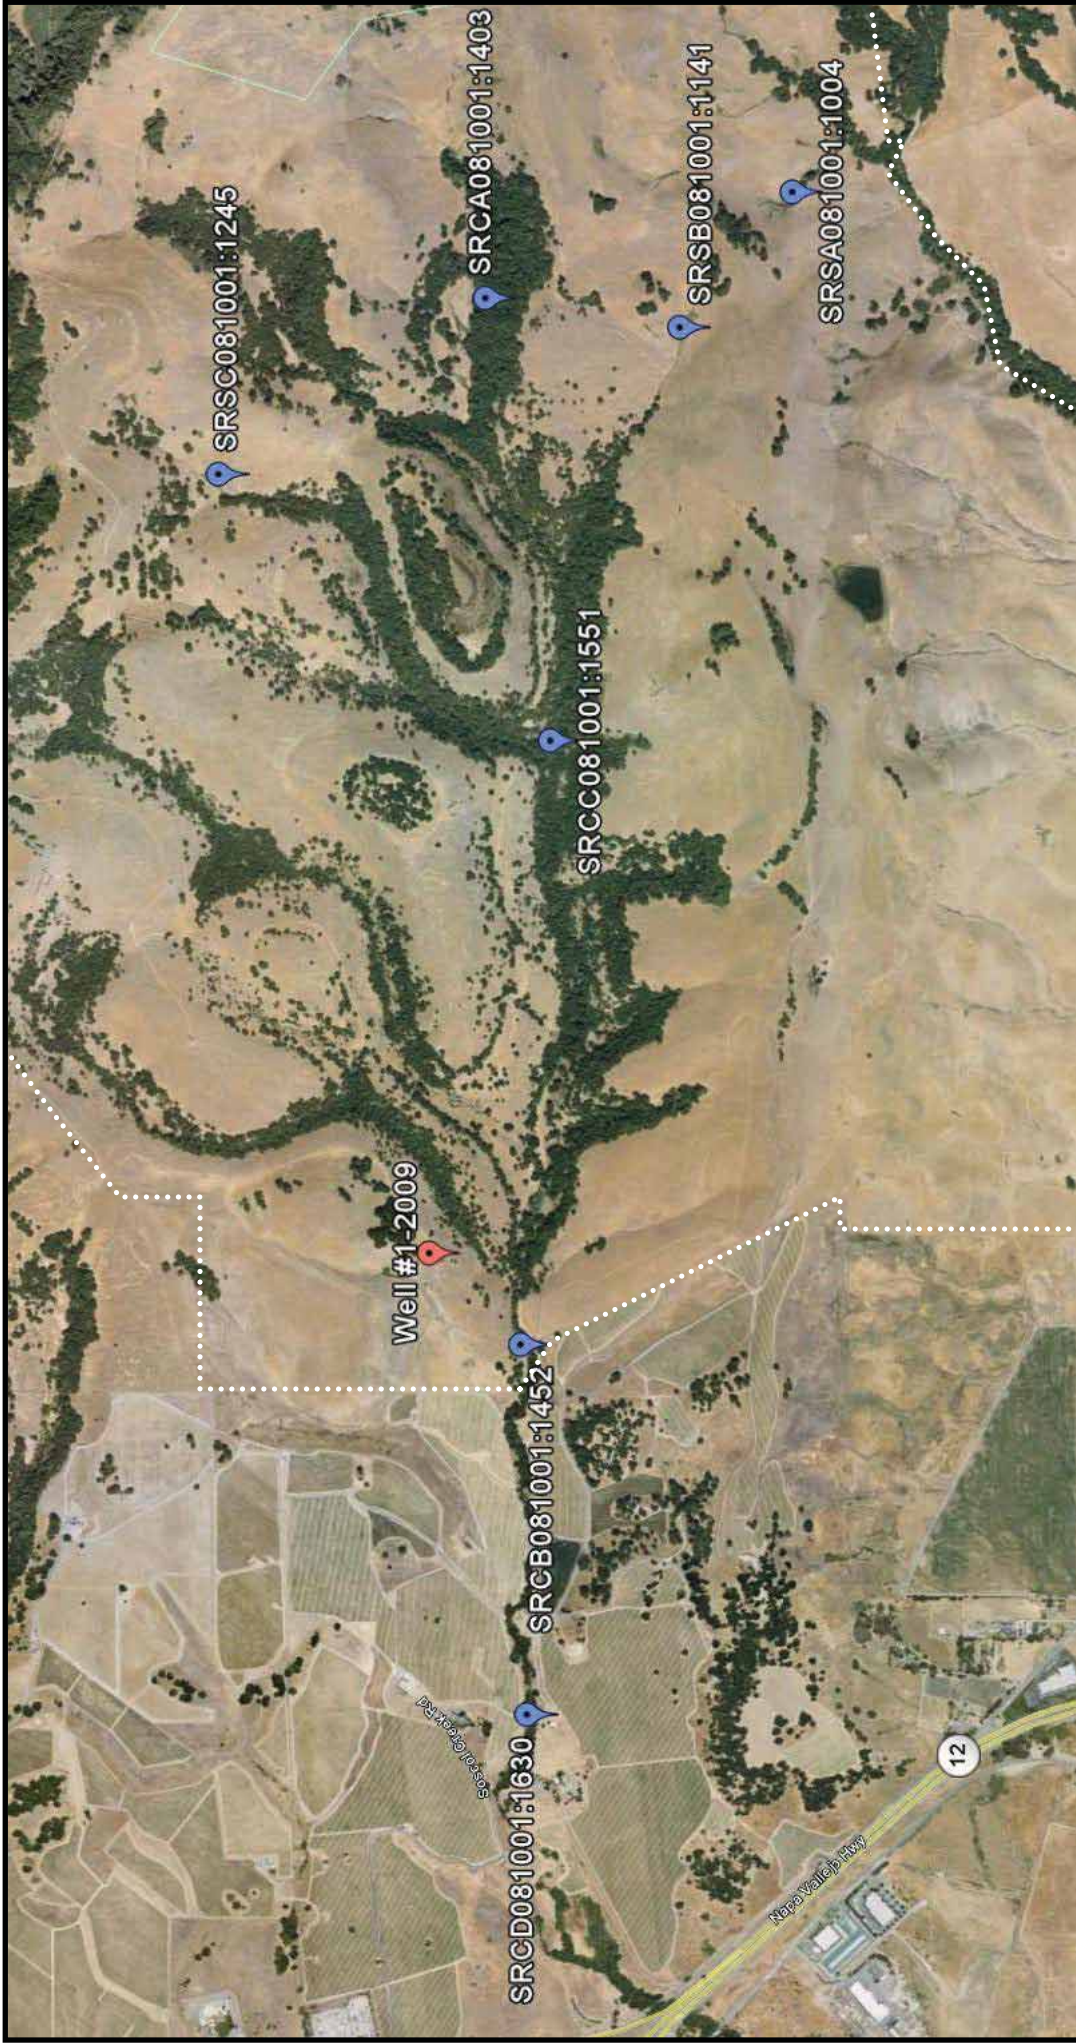
Figure 8. Spring locations and inferred recharge areas on the Suscol Mountain Vineyard property, Napa County, California.

Background image captured from Google Earth

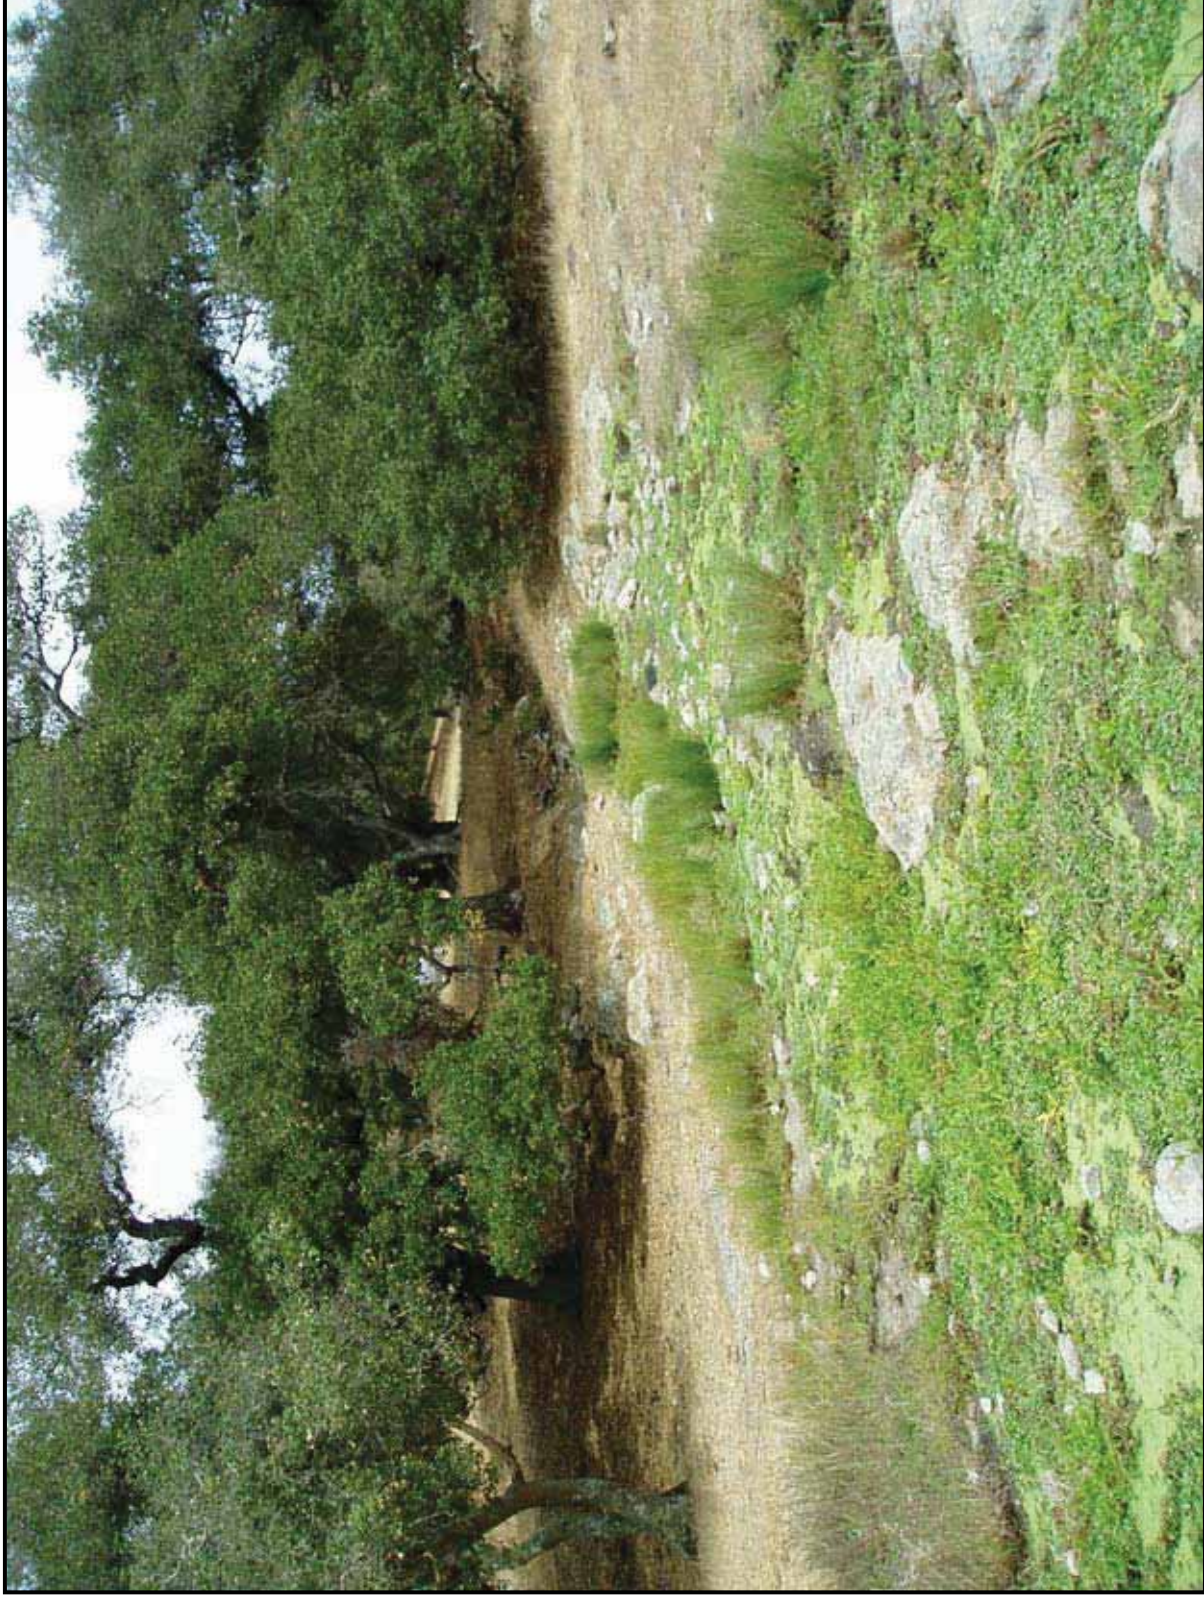
- Napa County, 2009. *Napa County Zoning Ordinance. Title 18, Napa County Code*. Napa County Conservation, Development and Planning Department. Available online at

Image captured October 1, 2008. The ground surface of the spring was saturated, but flow was too spread out to collect a reliable water sample for water chemistry analysis. Note the bedrock exposed at the ground surface in the foreground of the image.

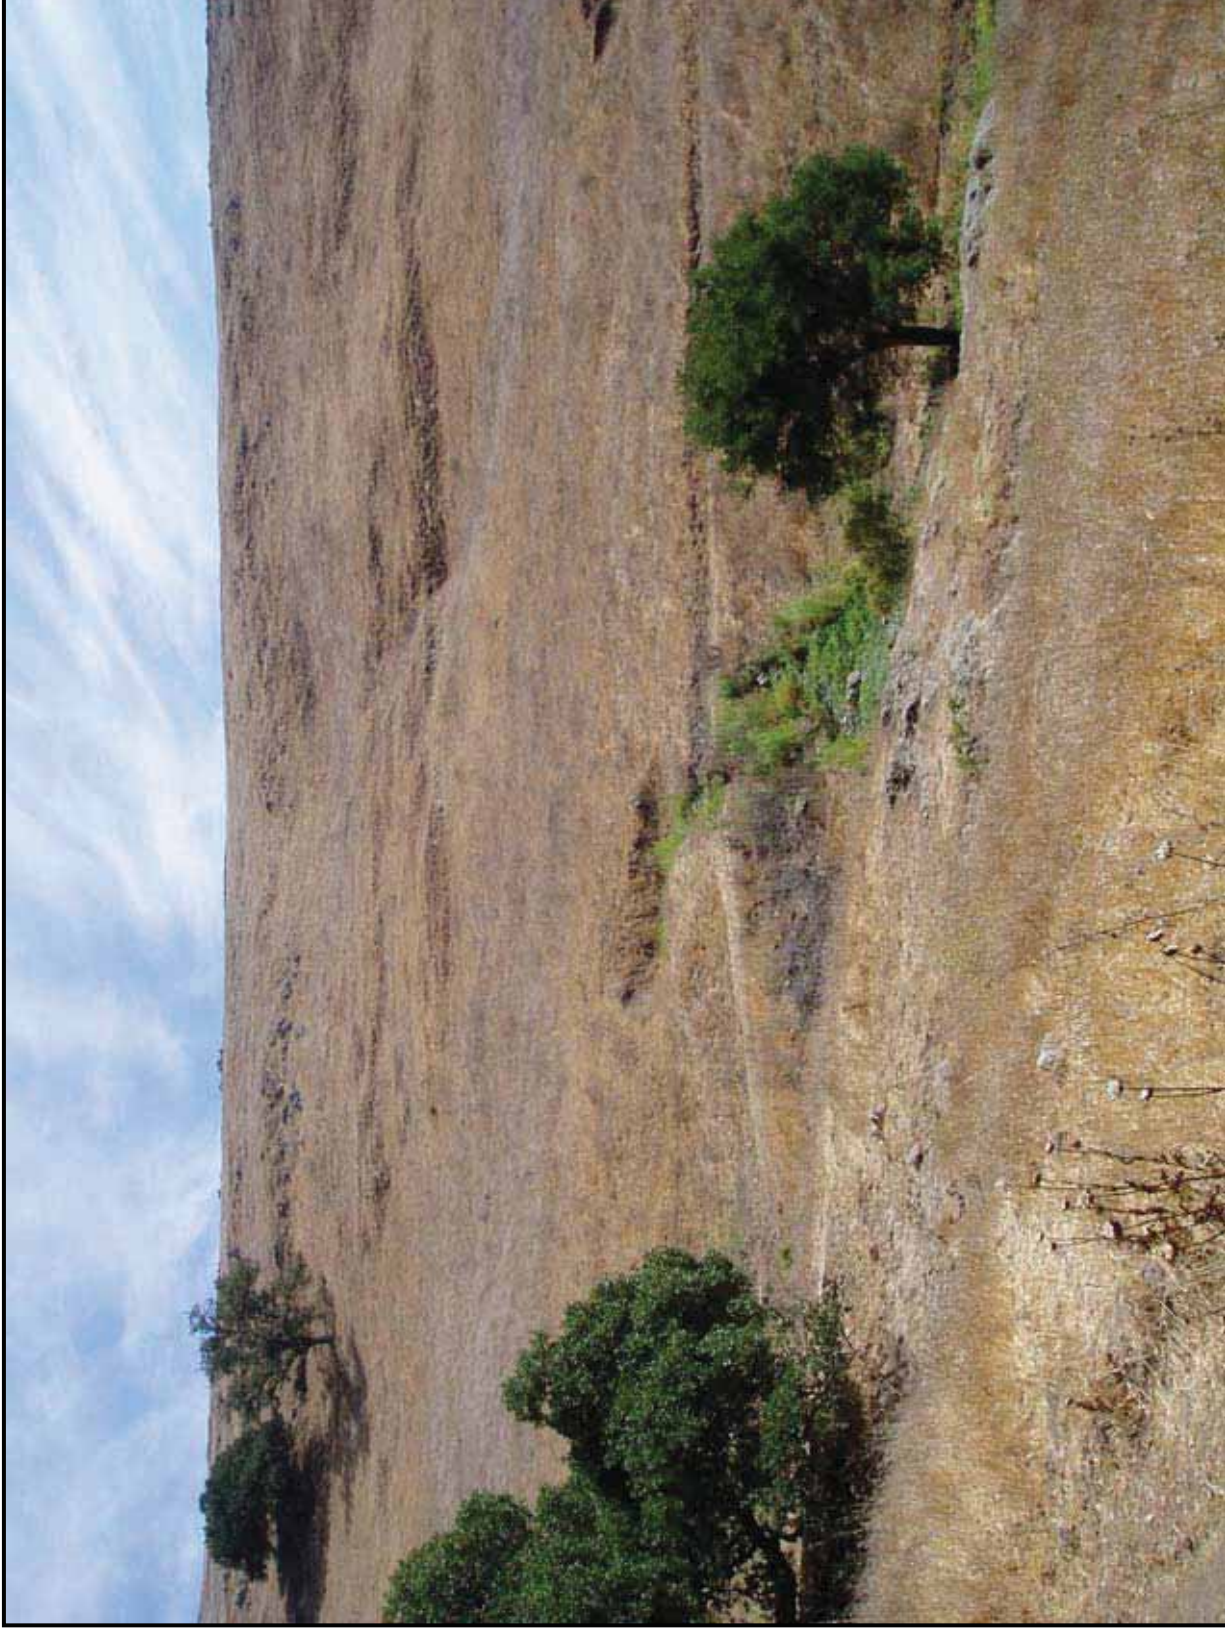
Figure 15. Photograph of spring 9, Suscol Mountain Ranch, Napa County, California.

Photo captured October 1, 2008. The Spring was flowing at greater than 2 gpm at the time of the site visit. Adjacent springs (just outside the right frame of the image) were contributing similar amounts of flow to the tributary stream.

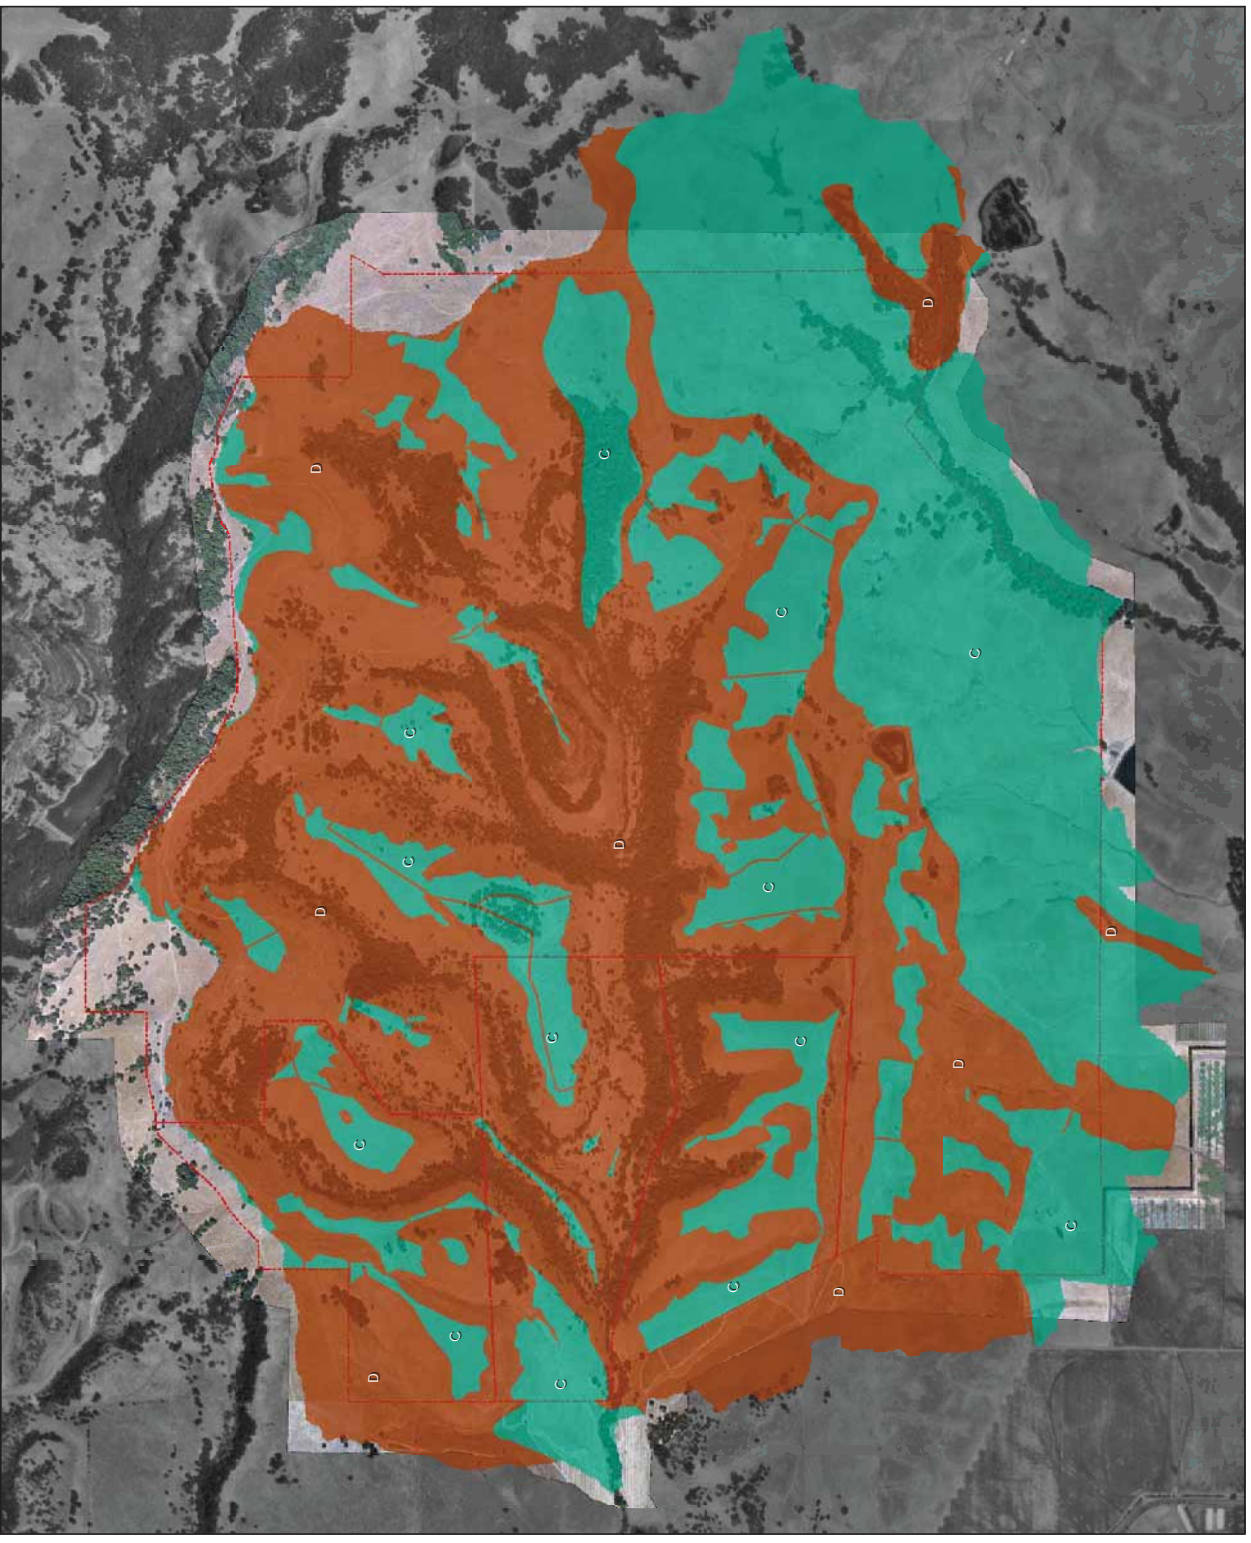
Figure 25. Existing curve numbers for Suscol Mountain Wineyard, Napa and Solano Counties, California

Soils present at the Suscol Mountain Vineyard property consist mainly of Fagan Clay Loams and the Hambright-Rock Outcrop Complex (Figure 22). The hydrologic group for the Fagan Clay Loams is C and the Hambright-Rock Outcrop Complex is D, giving the property very high runoff potential. In preparation for vineyard planting, the soil within each block will be ripped to a depth of approximately 36 inches. This is expected to improve infiltration within the Hambright soils group, resulting in a reclassification of the soil from hydrologic group D to C (Appendix E). This conversion would result in a decrease in the land use curve number in areas of Hambright soils because of the overall change in hydrologic group type (Figures 23 and 24). The resulting curve numbers for various portions of the subwatersheds are shown on Figures 25 (pre-project conditions) and 26 (post-project conditions).

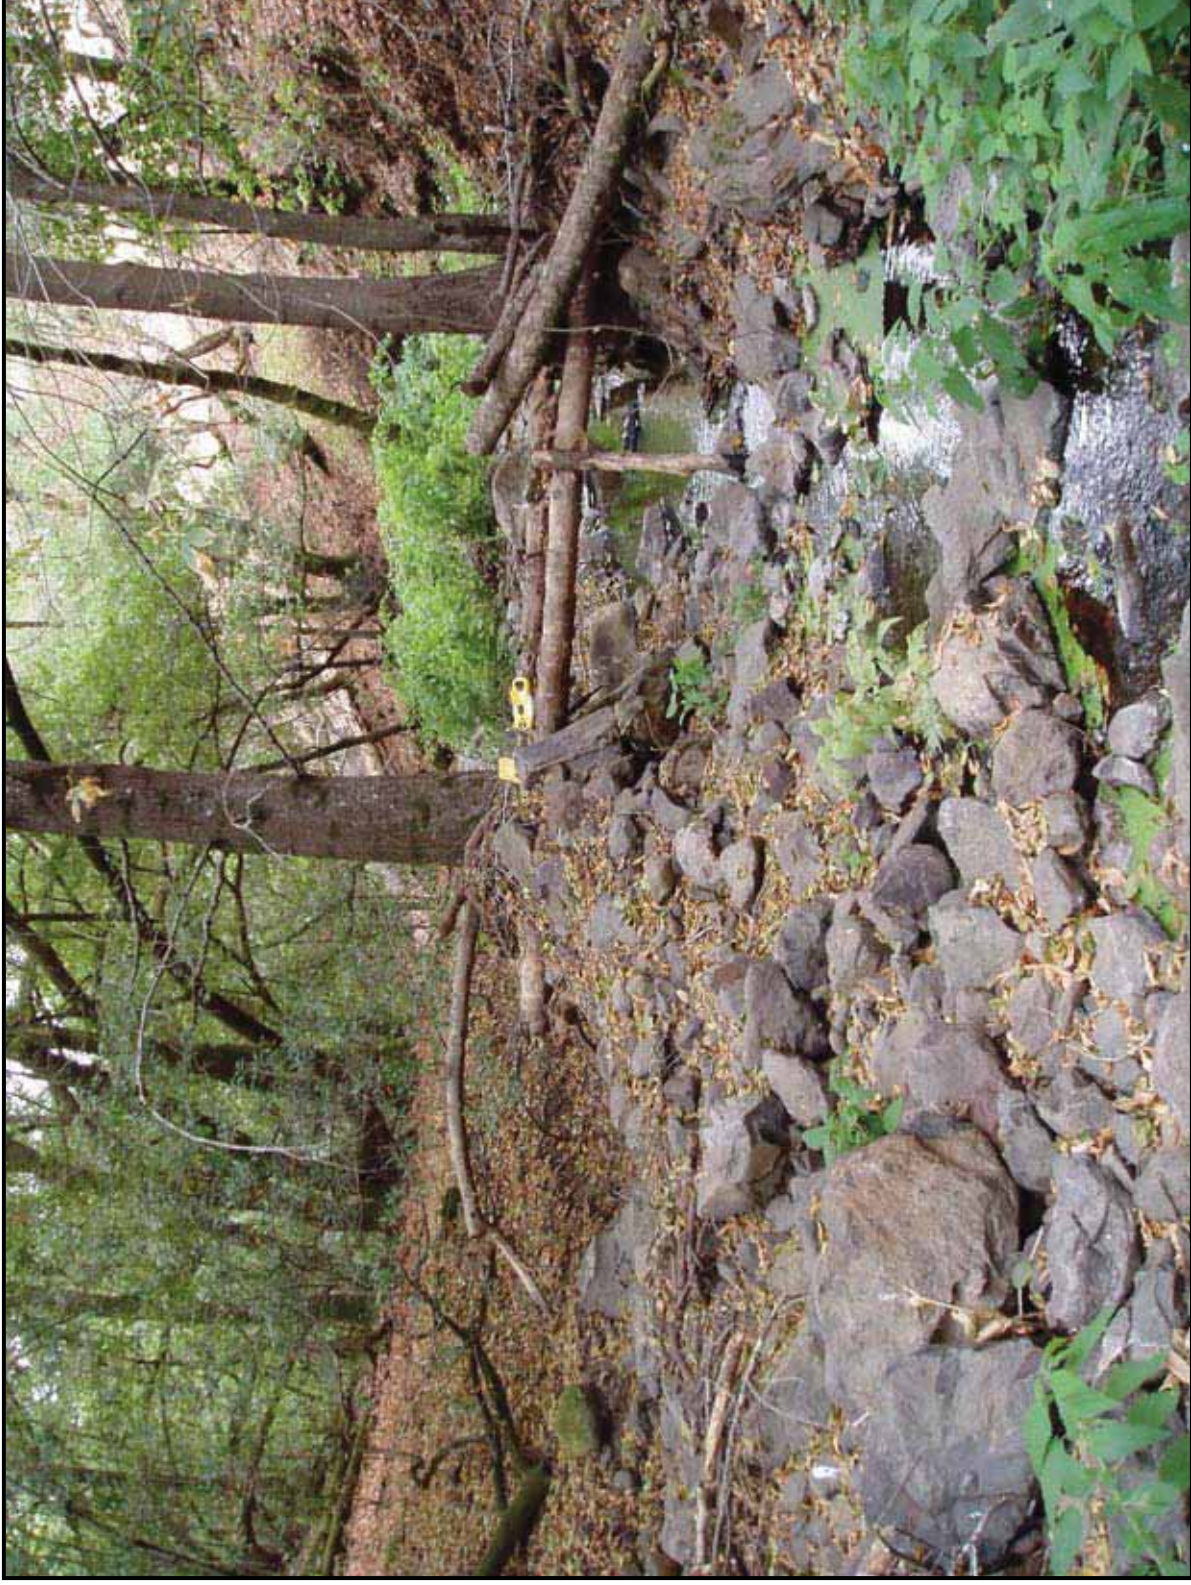
Figure 27. Photograph of channel conditions in Suscol Creek, Suscol Mountain Ranch, Napa County, California. Image captured October 1, 2008, approximately 0.6 miles upstream of the project property line. Streamflow in this reach was estimated at about 30 gpm.

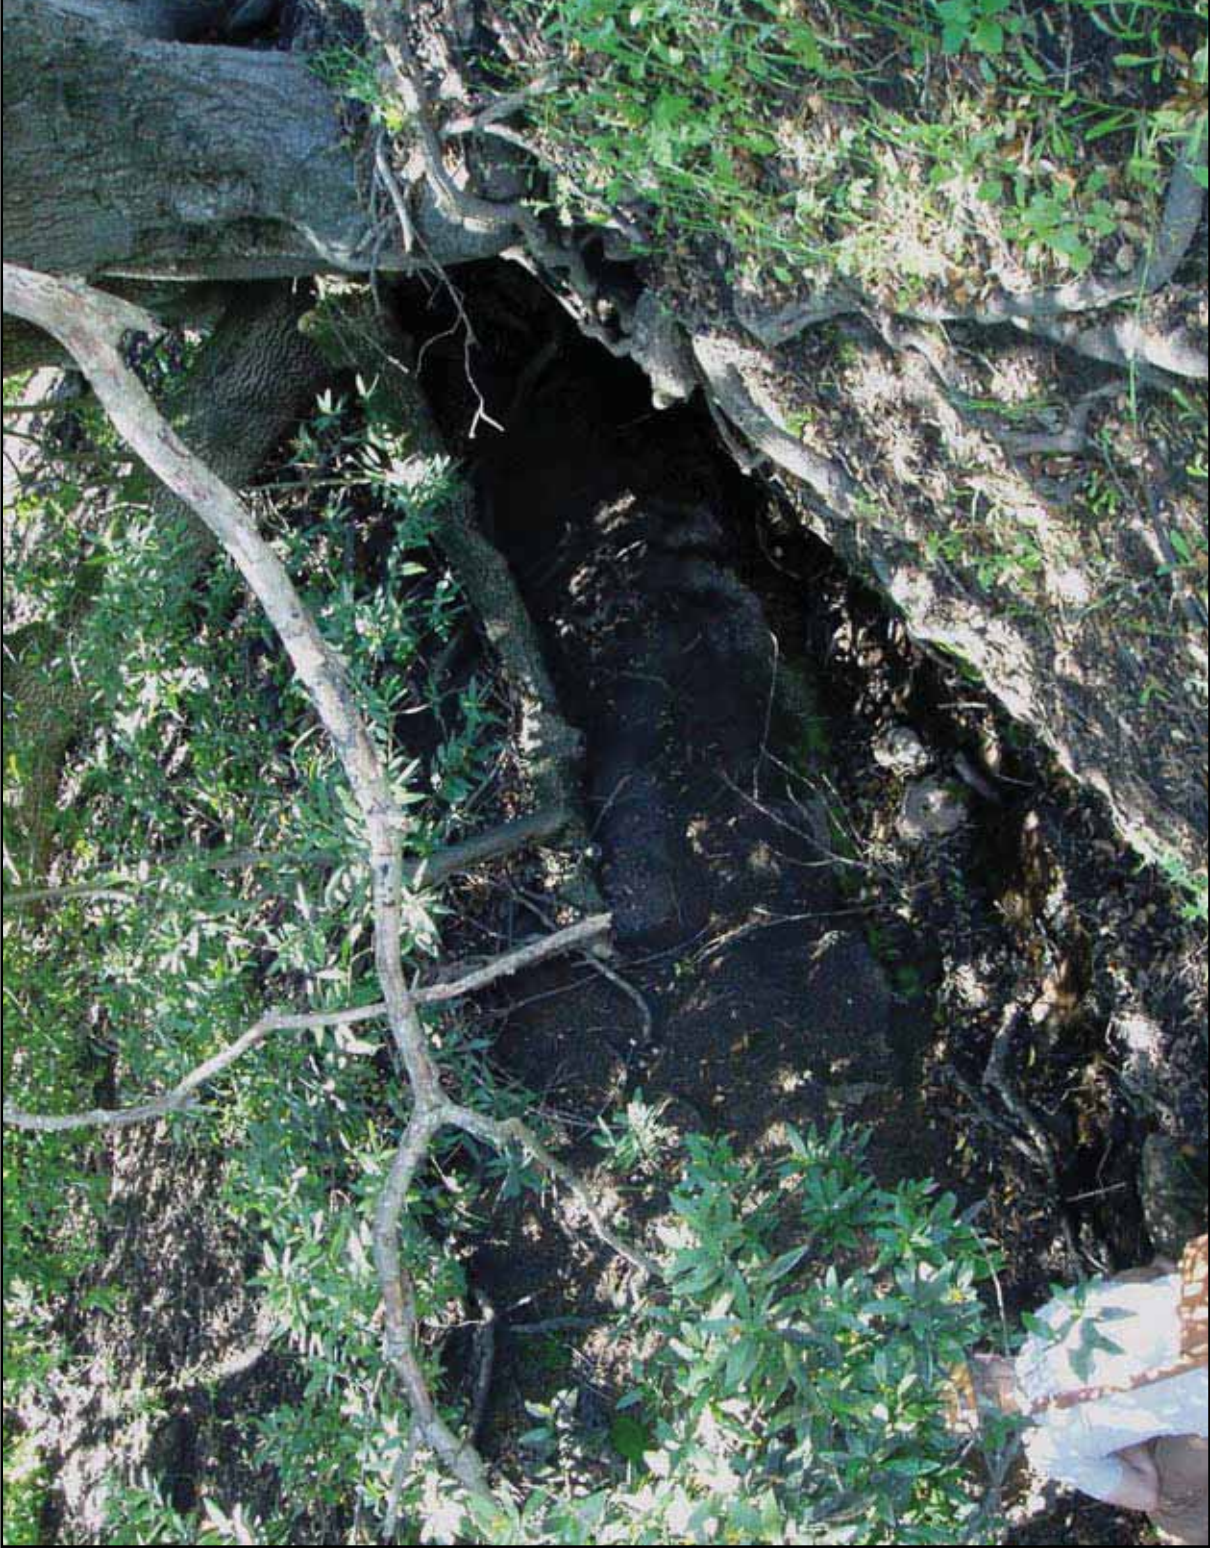
Figure 28. Photograph of channel conditions in Fagan Creek tributary 2 subwatershed, Suscol Mountain Ranch, Napa County, California. Image captured May 7, 2009, approximately 300 feet downstream of spring complex 27-30. Streamflow in this reach was estimated at about 5 gpm.
